# **PERFORMANCE TESTS OF SELECTED PLASTIC DRUMS**

**Prepared for  
Transportation Development Centre  
Transport Canada**

**by  
Environmental Simulation Lab  
Centre for Surface Transportation Technology  
National Research Council Canada**

**TP 14396E**

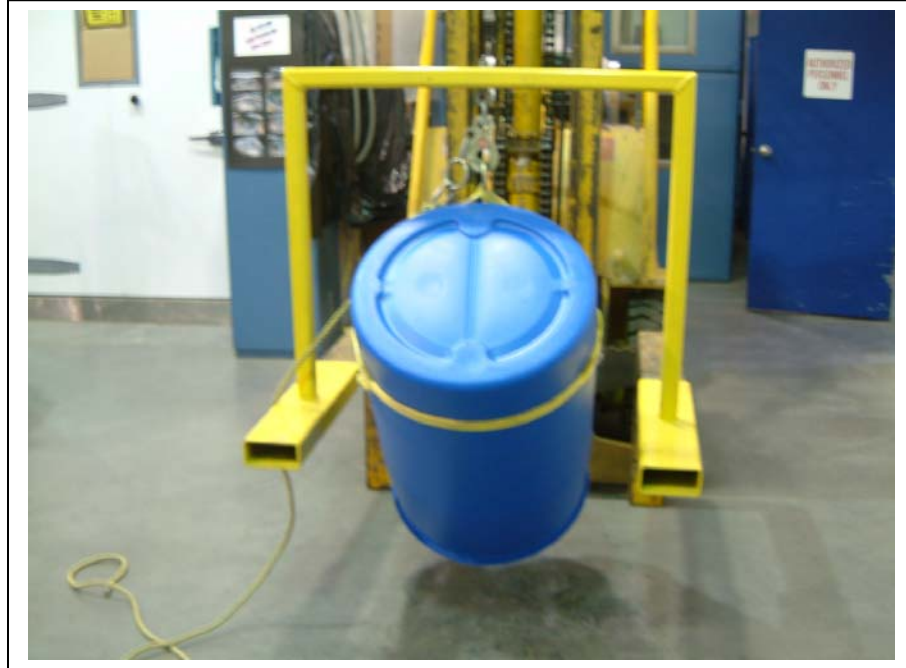
Photo 1 Test setup: Drum holding arrangement for indoor drops

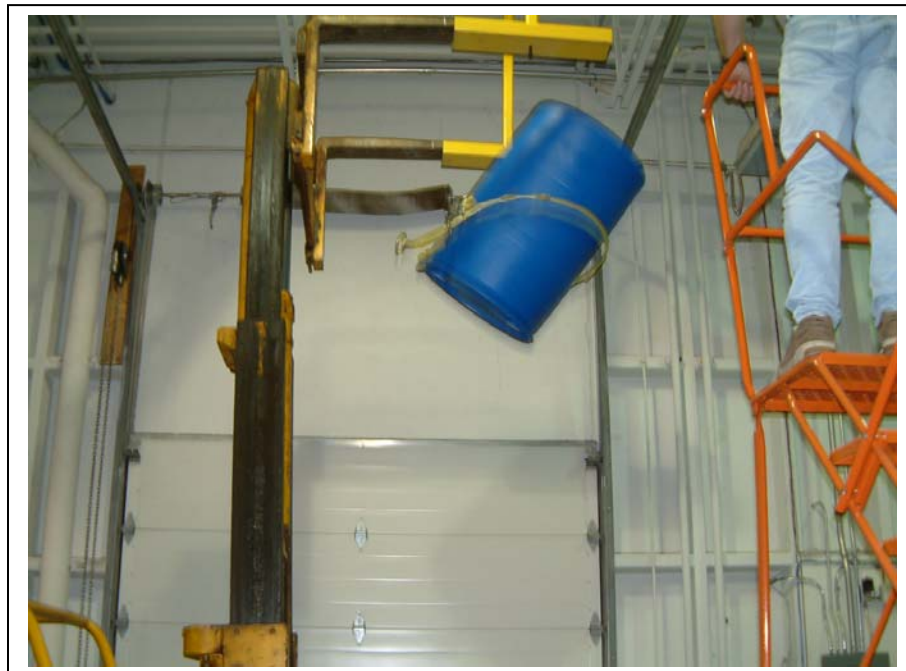
Photo 2 Test setup: Indoor drop underway

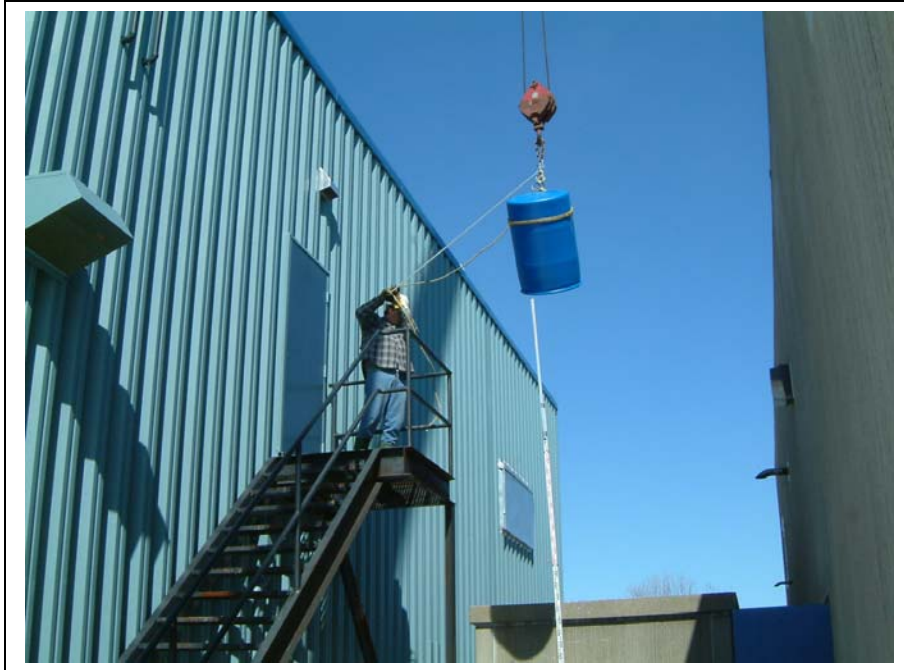
Photo 3 Test setup: Drum in final position for outdoor drop  
(required for higher drop heights)

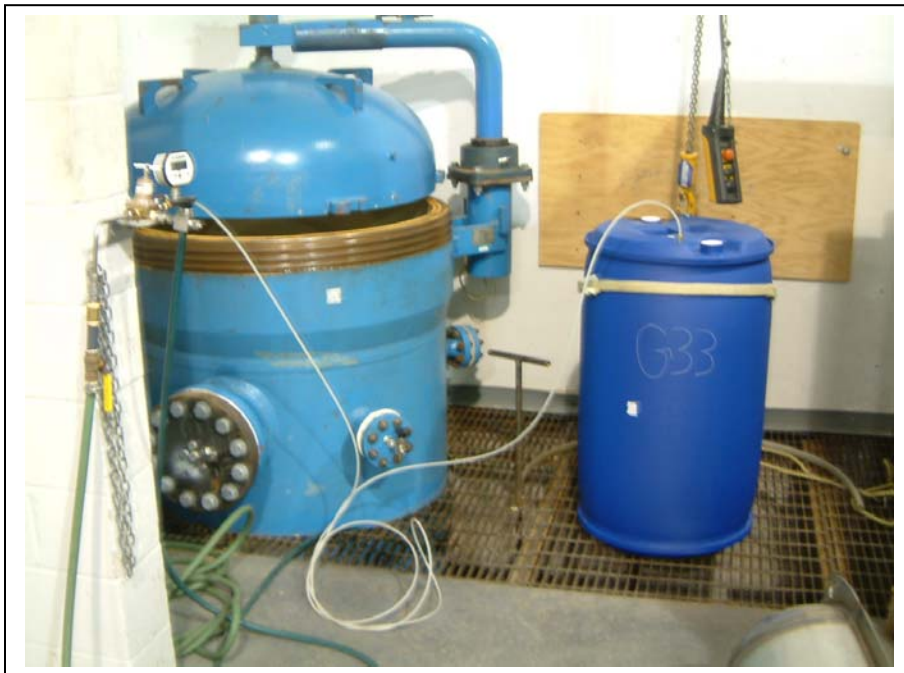
Photo 4 Test setup: Internal pressure test

The pressure was increased until either a leak was observed or the pressure reached 1.5 times that for which the drum was rated.

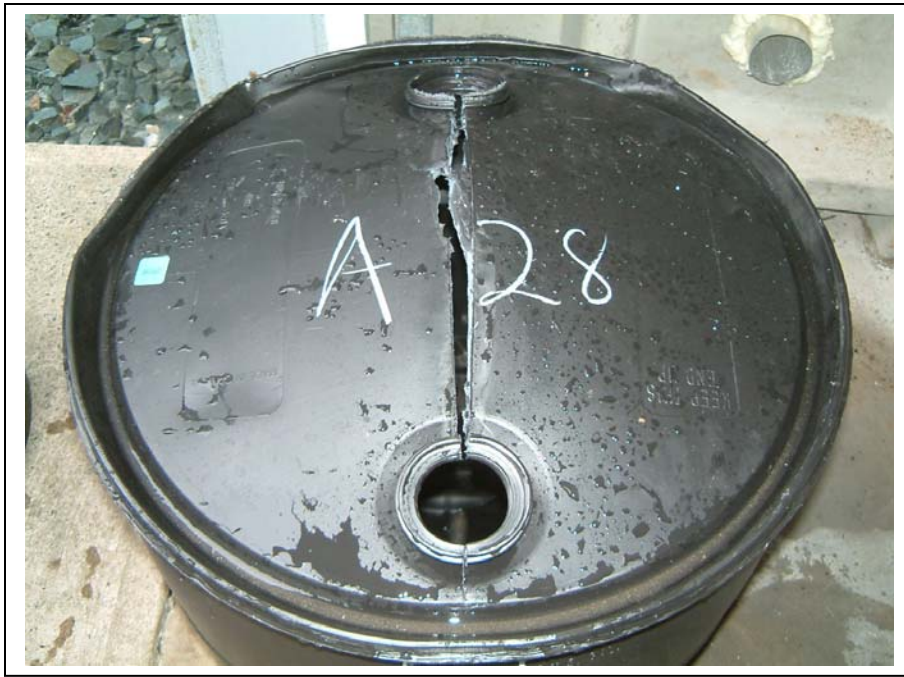
Photo 5 Drum Set A: Typical failure mode - Fracture at cover mold line

Out of all the failures, most were due to splitting of the top cover along the mold part line. A few drums split where the cover joined the body. There were no failures of either closure observed during the official series but one NPS closure leaked and another popped off during the preliminary tests.

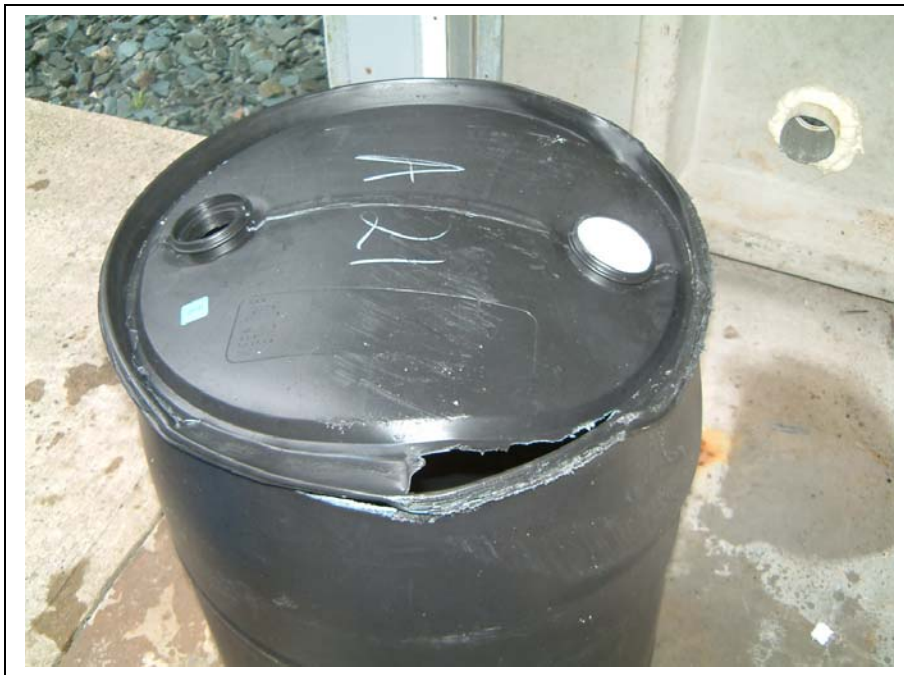
Photo 6 Drum Set A: Typical failure mode - Fracture at cover/body seam

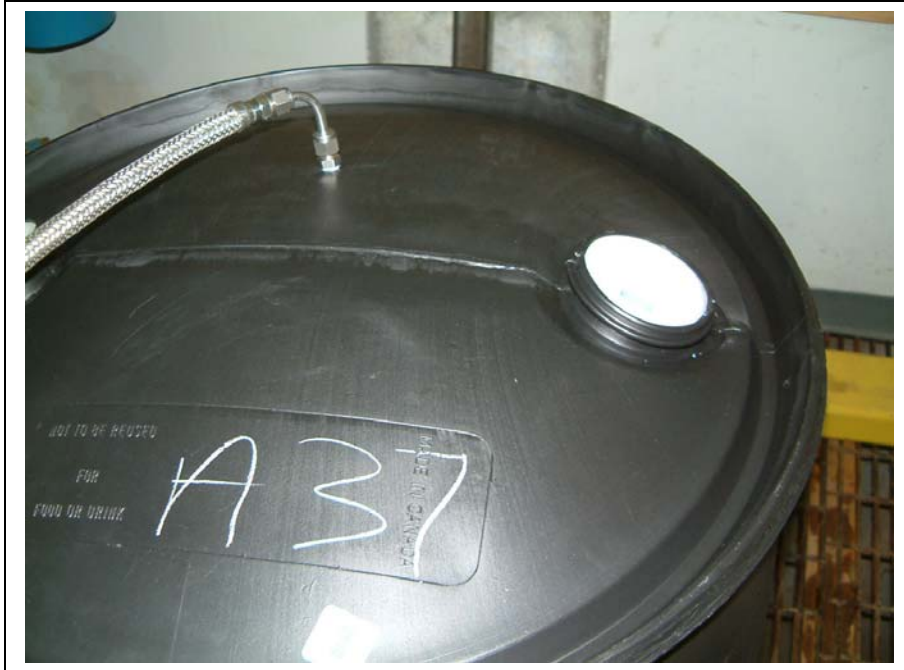
Photo 7 Drum Set A: Pressure test in showing test fitting location

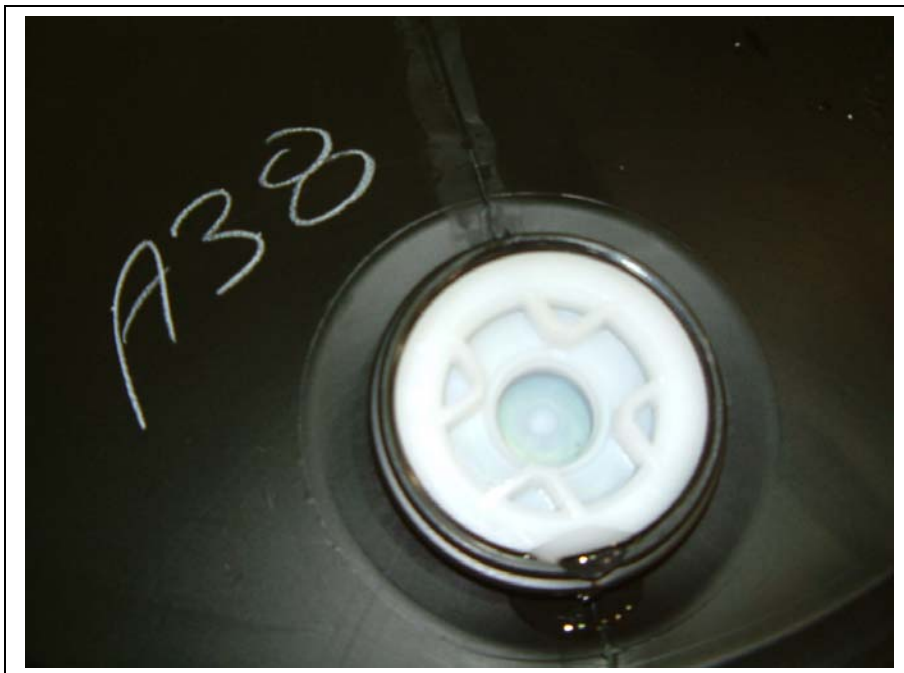
Photo 8 Drum Set A: Typical pressure test failure mode - Drip from NPS closure

Drum No.	Pressure achieved, kPa	Comments
A37	186	Leak at NPS closure
A38	154	Leak at NPS closure, and buttress closure
A39	224	Leak at NPS closure
A40	229	Leak at NPS closure, and buttress closure
A41	214	Leak at NPS closure
Average	201 kPa	Rated press. = 150 kPa

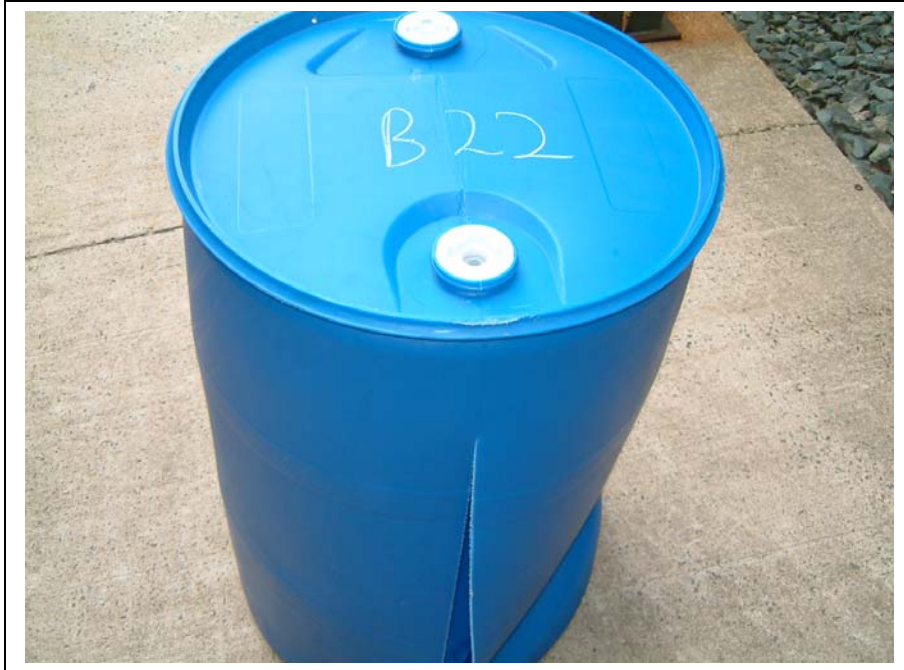
Photo 9 Drum Set B: Failure mode - Longitudinal fracture of body

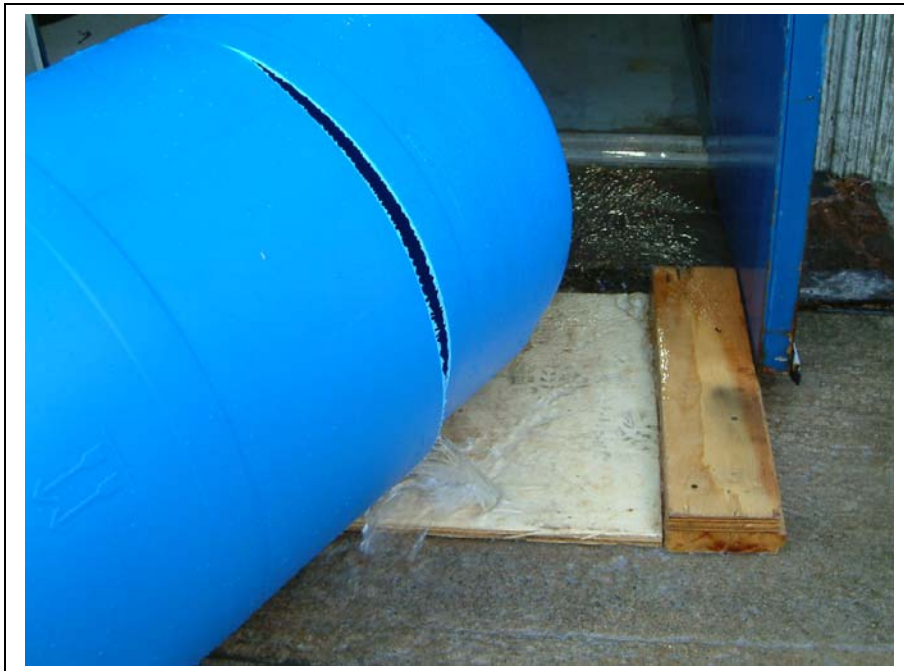
Photo 10 Drum Set B: Failure mode - Circumferential fracture next to rolling rib

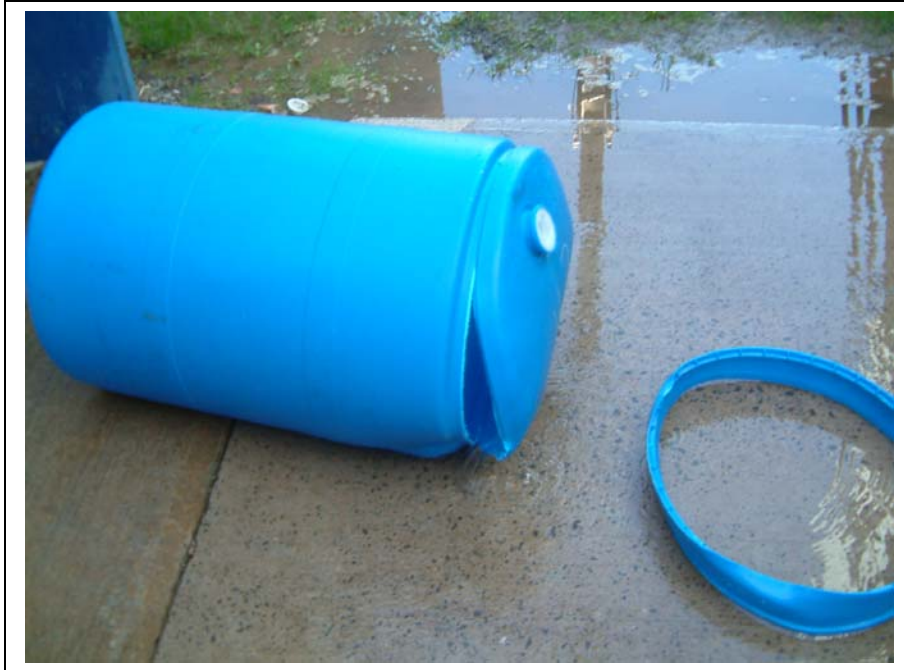
Photo 11 Drum Set C: Failure mode - Fracture at cover/sidewall seam (note top ring separated)

Set C was one of two that used a separate, pressed on ring to form the spill containment reservoir around the top. These sometimes came off when the drum was dropped, and the failure sometimes occurred around the recess into which this ring was pressed.

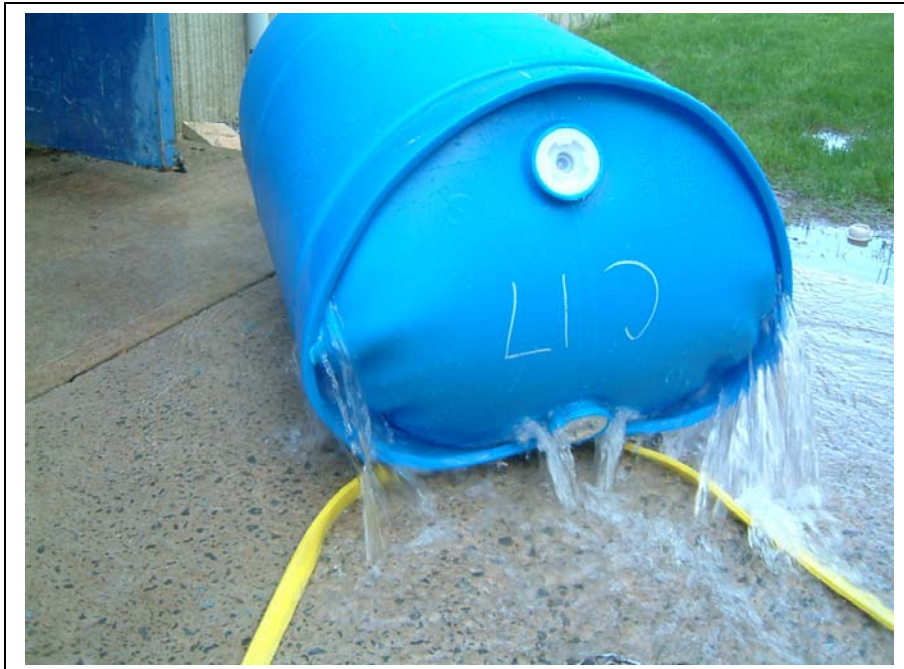
Photo 12 Drum Set C: Failure mode - Fracture at cover/sidewall seam, under the recess where top ring locates

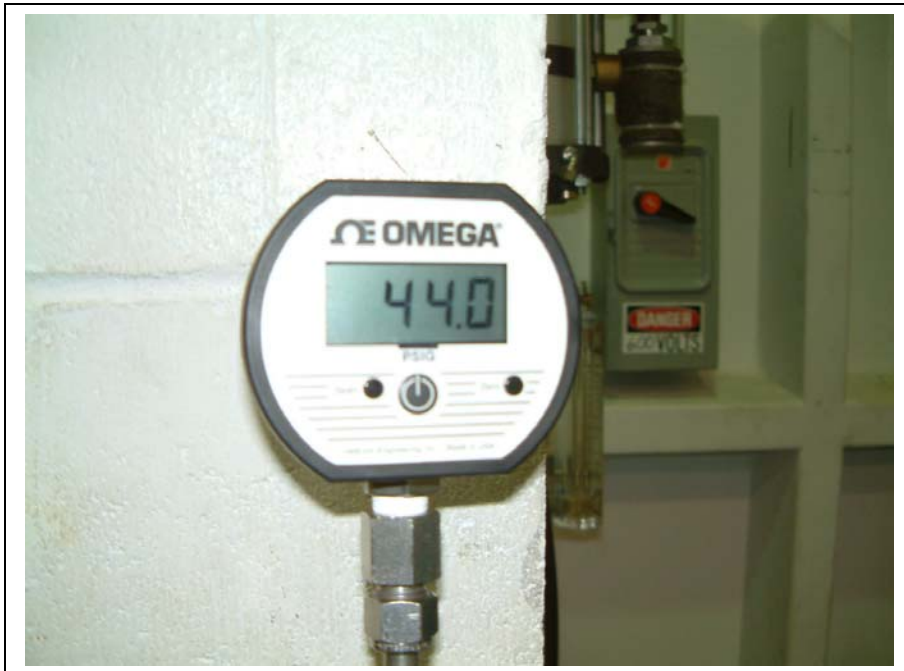
Photo 14 Drum Set C: Pressure test - Maximum pressure reached, no leaks

Drum No.	Pressure achieved, kPa	Comments
C3	303	No leaks: test stopped at approx. 200% rated
C4	276	No leaks: 150% rated
C5	276	No leaks: 150% rated
C6	276	No leaks: 150% rated
C7	276	No leaks: 150% rated
<b>Average</b>	<b>&gt; 276 kPa</b>	<b>Rated press. = 150 kPa</b>

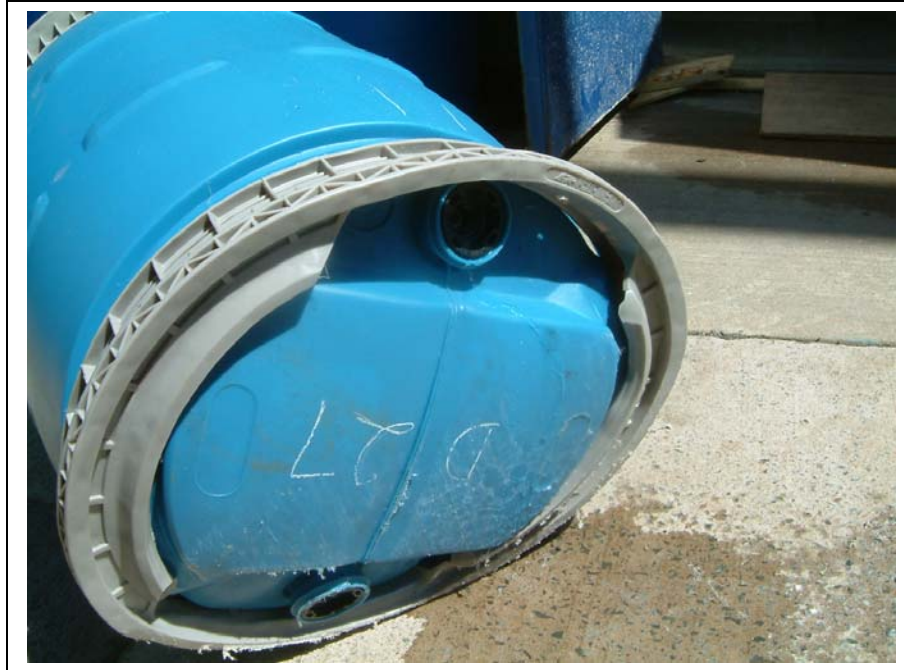
Photo 15 Drum Set D: Failure mode - Dripping from opposite closure from the one impacted

The mean and standard deviation were calculated to be 6.64 m and 0.66 m, respectively. Even at these extreme heights, there were no catastrophic failures, with most failures consisting of a slight leak at the closure or a small pin-hole at a fold.

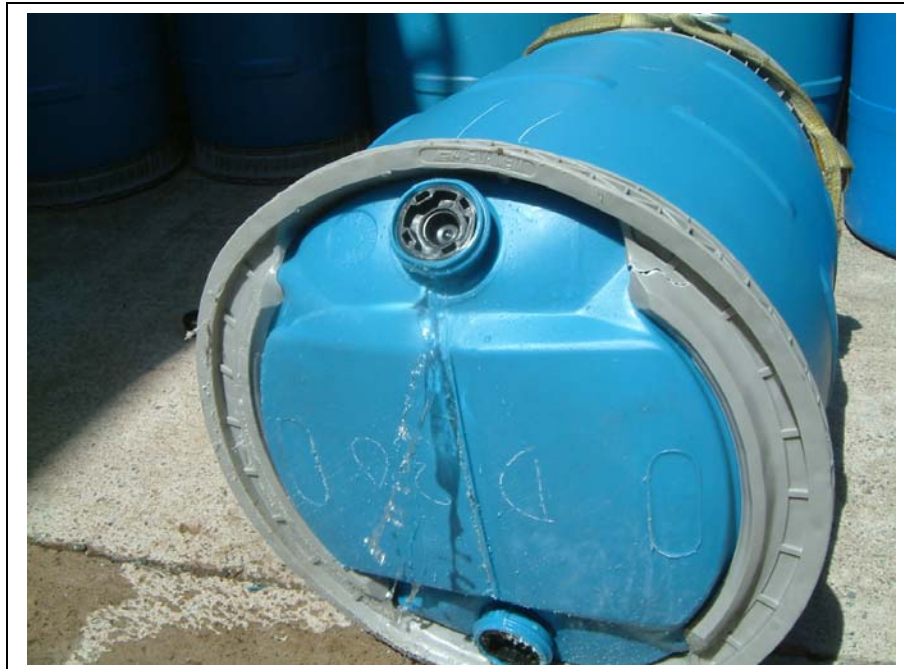
Photo 16 Drum Set D: Failure mode - Small split on closure neck (opposite from impact side)

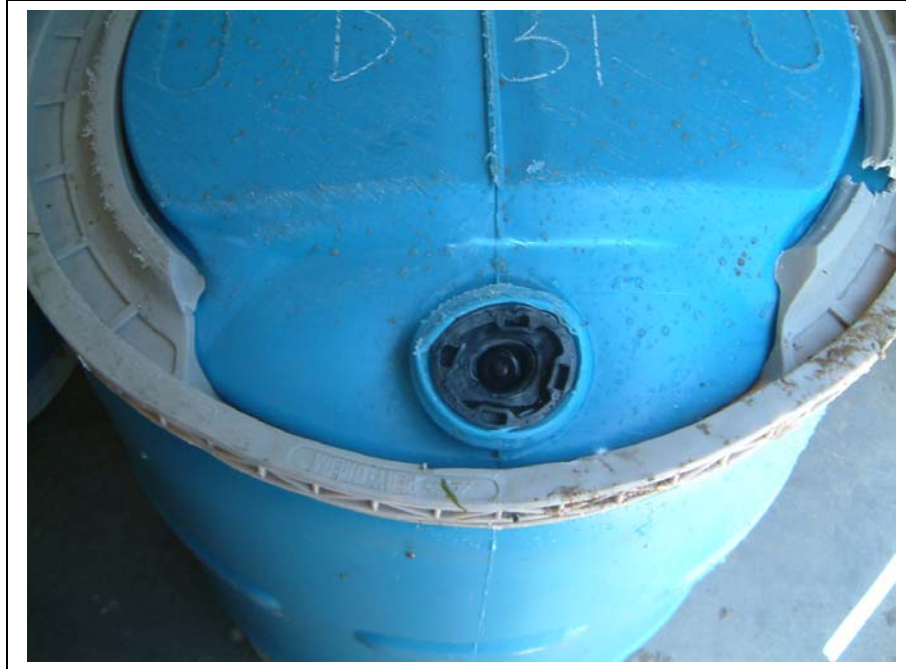
Photo 17 Drum Set D: Example of severely distorted closure neck – Still no leaks

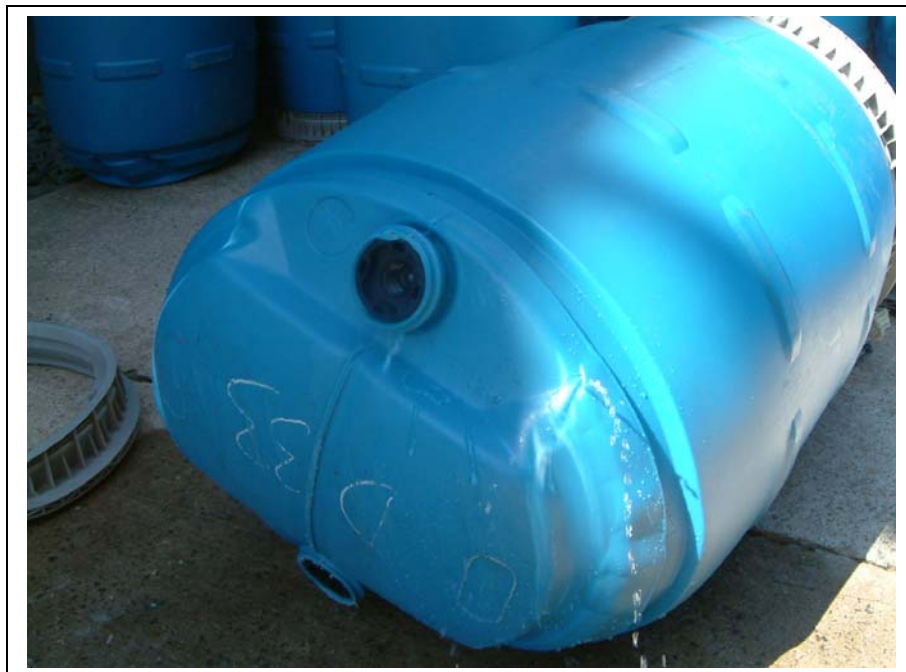
Photo 18 Drum Set D: Failure mode - Small split on edge of top/sidewall seam

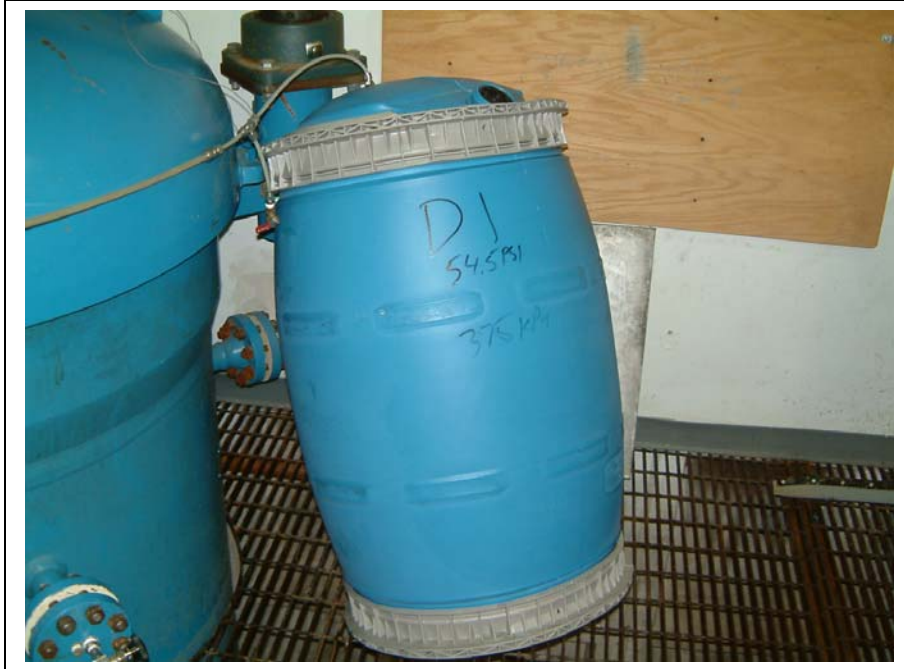
Photo 19 Drum Set D: Pressure test at maximum pressure

Drum No.	Pressure achieved, kPa	Comments
D1	375	No leaks after 5 min at 150% rated
D2	375	No leaks: 150% rated
D3	375	No leaks: 150% rated
D4	375	No leaks: 150% rated
D5	375	No leaks: 150% rated
Average	> 375 kPa	Rated press. = 250 kPa

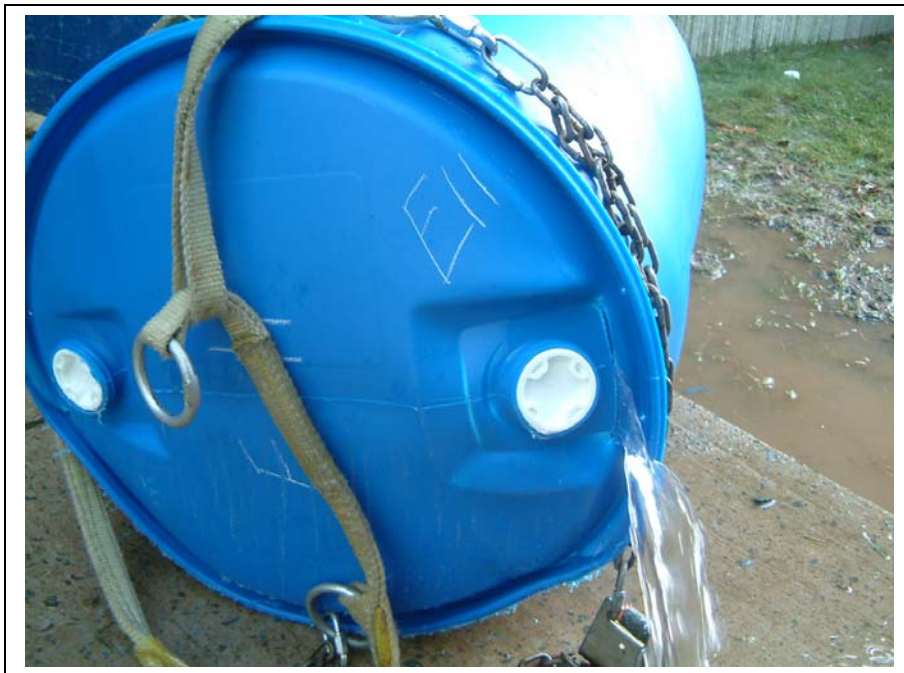
Photo 20 Drum Set E: Failure mode - Fracture between closure neck and top/sidewall seam

The mean and standard deviation for the 8 o'clock drops were calculated to be 3.76 m and 0.6 m, respectively. Most of the failures were due to a leak at one of the buttress thread closures. A few, mainly from the higher drop heights also split along the top, usually adjacent to the closure.

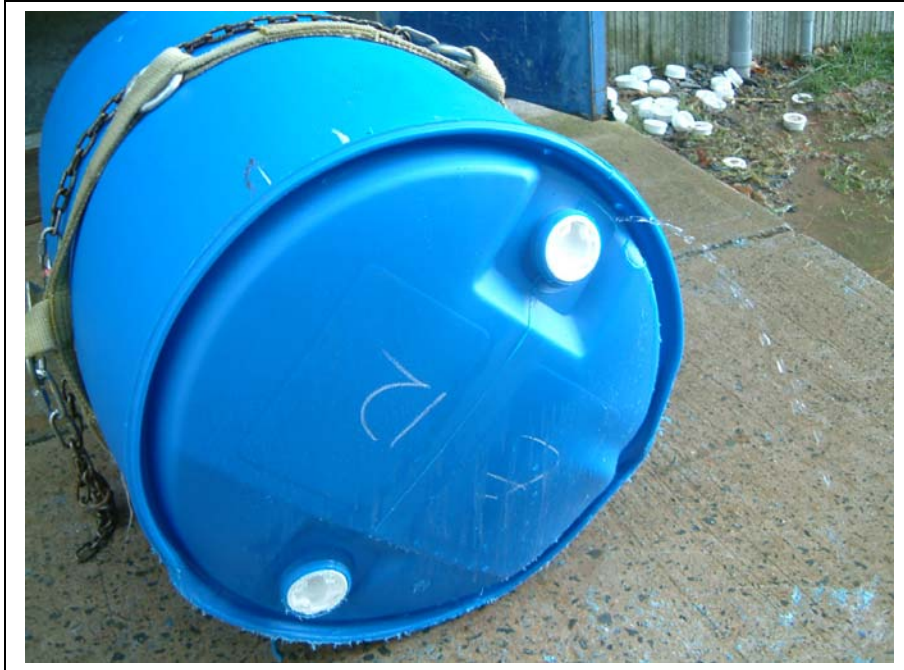
Photo 21 Drum Set E: Failure mode - Small hole near closure neck

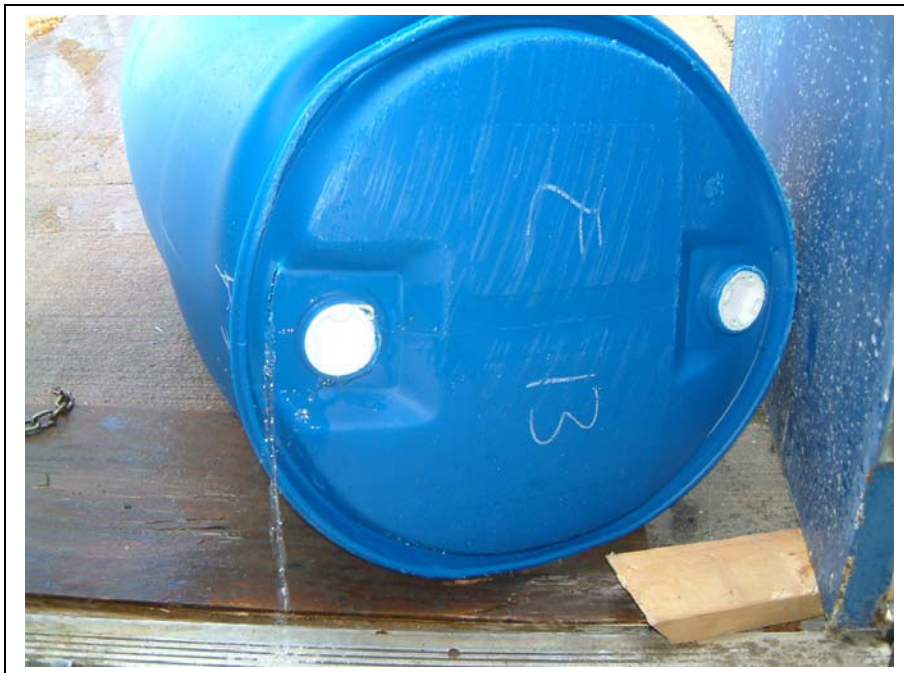
Photo 22 Drum Set E: Failure mode - Separation at edge of closure well

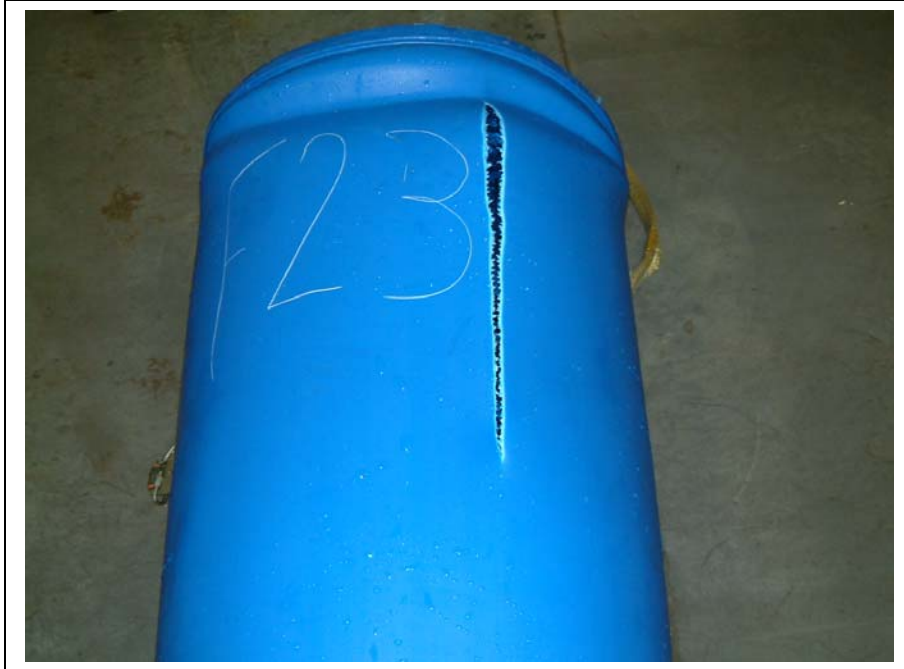
Photo 23 Drum Set F: Failure mode - Longitudinal split along sidewall

The difference between drop orientations was definite, with the 6 o'clock orientation being the more vulnerable of the two. The mean and standard deviation were calculated to be 3.4 m and 0.28 m, respectively, for the six o'clock drops. The failure mode was either by fracturing along the sidewalls, or the top fracturing in the vicinity of the closure. No failures were by closure leakage.

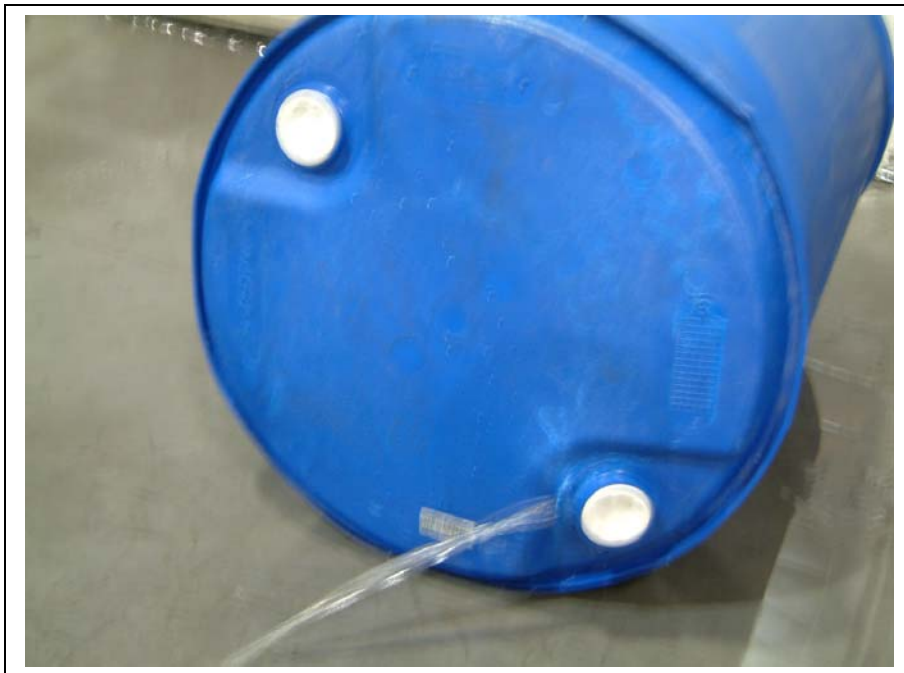
Photo 24 Drum Set F: Second failure mode - Rupture around closure

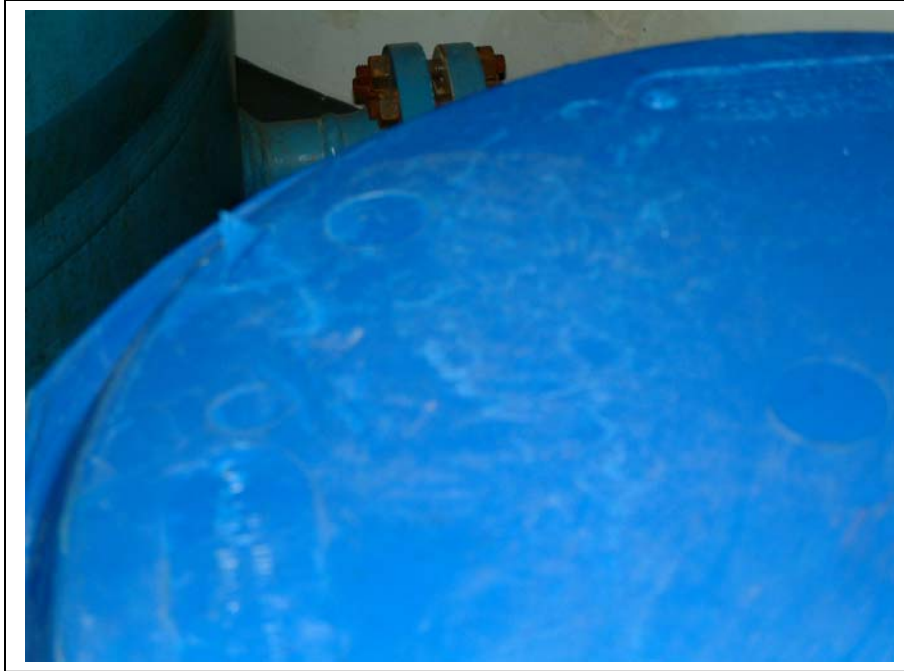
Photo 25 Drum Set F: Close-up of drum top showing delamination of material

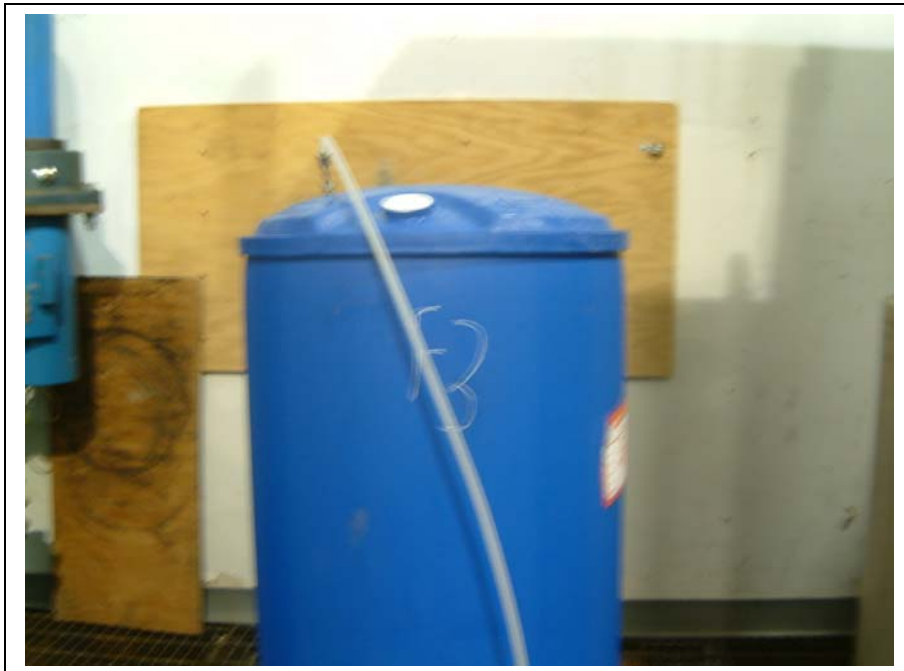
Photo 26 Drum Set F: Pressure test under way

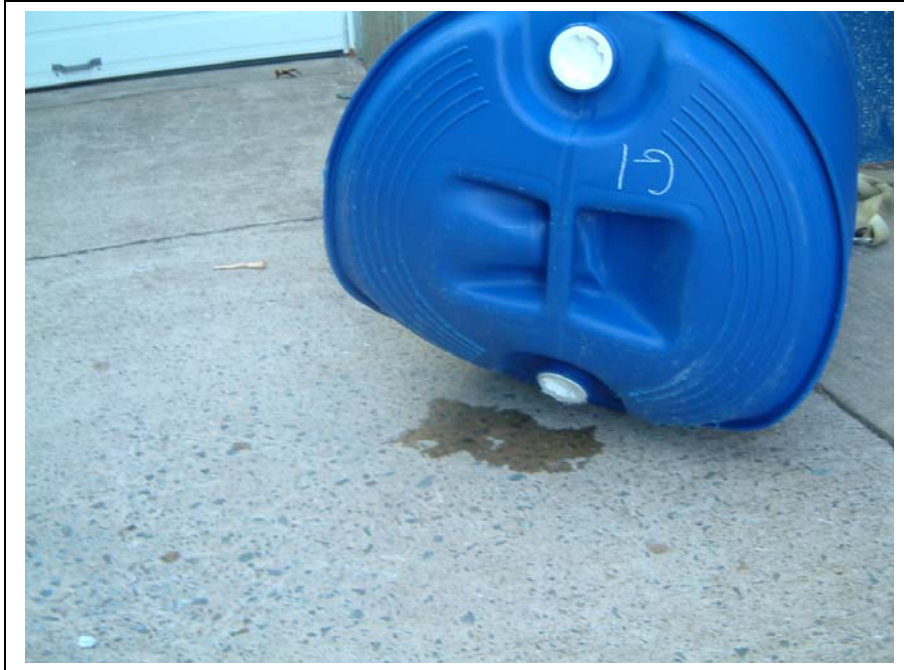
Photo 27 Drum Set G: Failed drum showing extent of distortion of top handle area

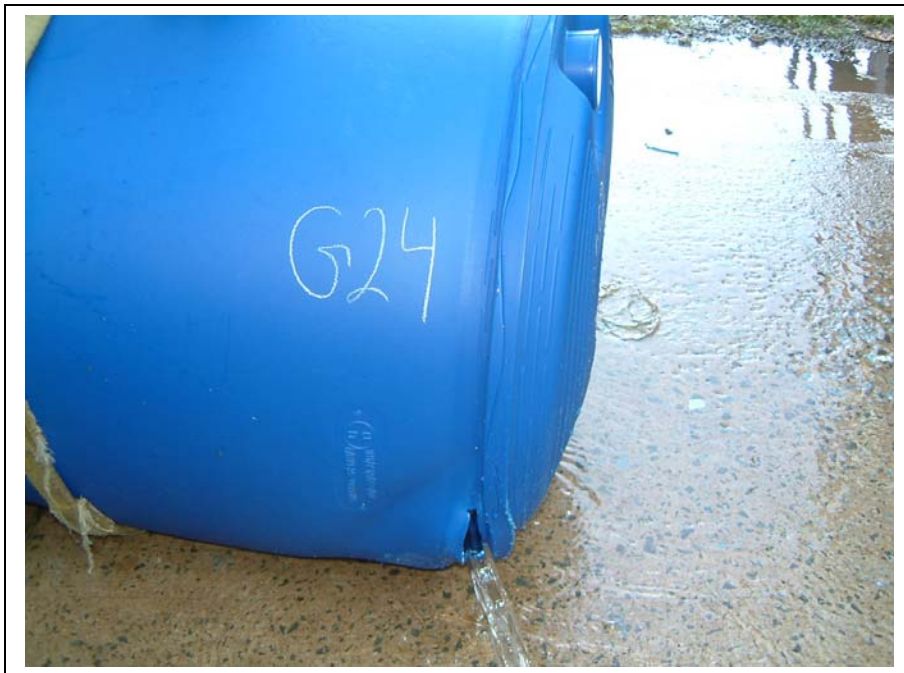
Photo 28 Drum Set G: Typical failure mode - Rupture at top/sidewall line

The mean and standard deviation were calculated to be 3.64 m and 0.27 m, respectively, for the six o'clock drops. The failure modes were about evenly divided between closure leakage, and the top fracturing in the vicinity of the closure. A few drums also failed by longitudinal fractures along the body sidewalls.

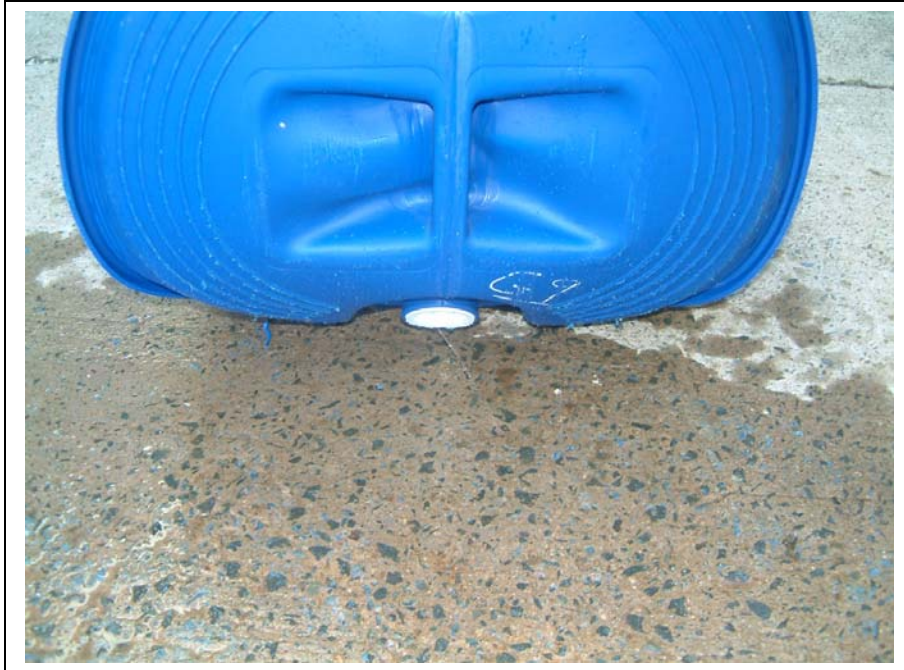
Photo 29 Drum Set G: Second failure mode - Leaking from closure

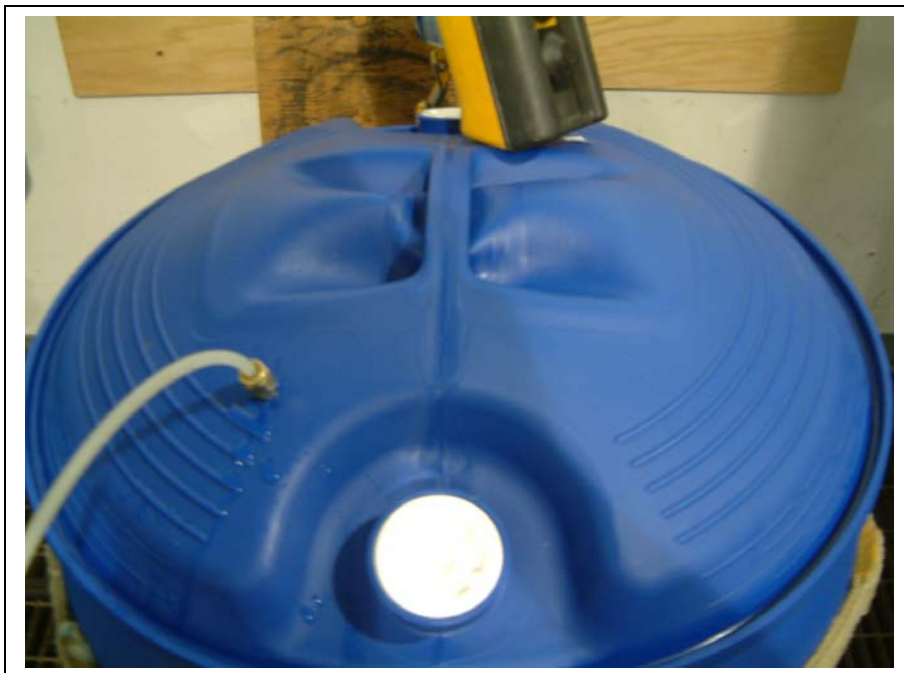
Photo 30 Drum Set G: Pressure test under way

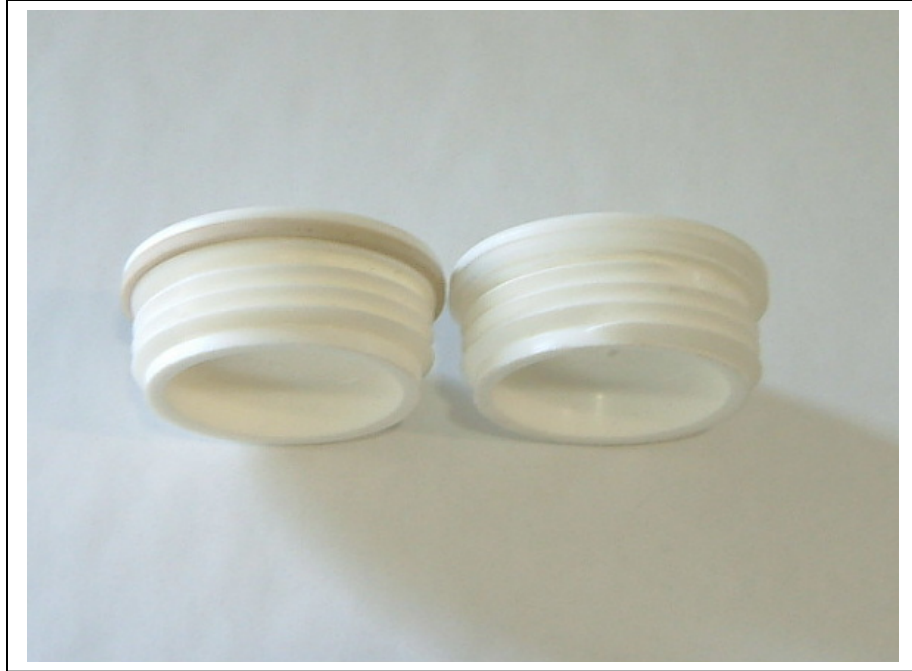
Photo 31 Comparison of two gasket types: Rectangular section, soft rubber on the left, round section, hard plastic on the right (both closures with butress threads)

This was particularly difficult for closures with the hard plastic gaskets. The torque of 27.1 J (20 ft-lb) that worked for closures with soft rubber gaskets was entirely inadequate for closures with hard plastic gaskets. After several attempts to contact the manufacturers, it was decided to try increasing the torque until a value was found that appeared to work. Often a value of 40.7 to 47.5 J (30 to 34 ft-lb) would seal, but 54.2 J (40 ft-lb) would cause the threads to be stripped, while lower values would result in a leaking closure at very low pressures.

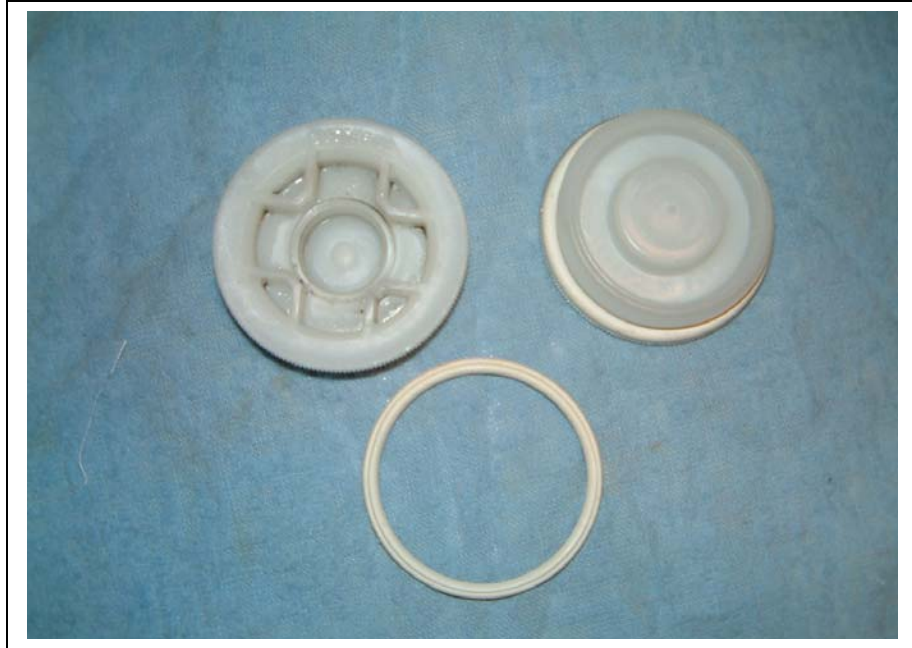
Photo 33 Example of a type c closure:  
Note the small, threaded knockout bung in the centre
